Manhole Inspection Summary

Manhole # S71G__016MH

Insp Date: **5/21/08 8:16 AM**

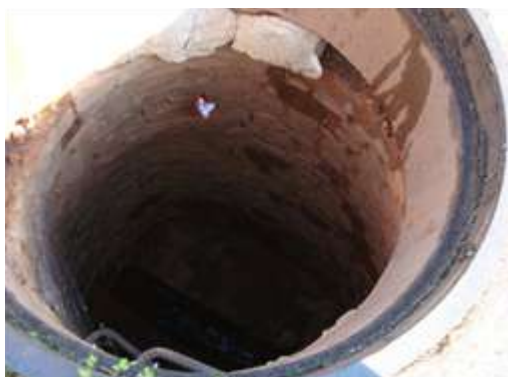
Defect 1

Condition: ☐ Sound ☐ Cracked ☐ Root Intrusion ☒ **Loose Brick** ☐ Deteriorated

loose bricks

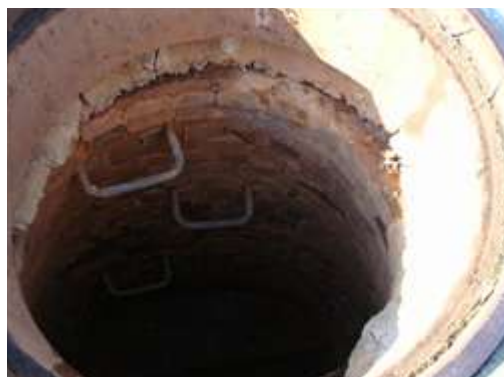
Defect 2

Infiltration: ☐ None ☒ **Joint** ☐ Cracks ☒ **Mortar** ☐ Roots ☐ Wall

infiltration

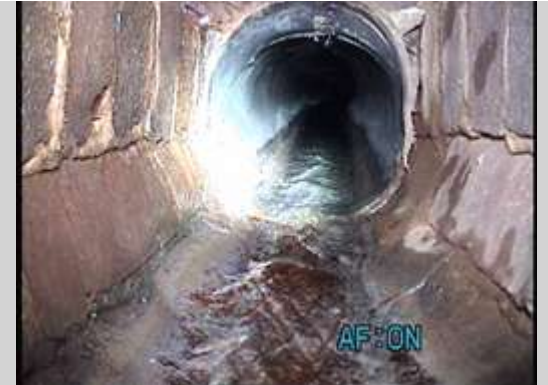
12 O'Clock Outflow

8 in. Circular Gravity Sewer
Pipe Out @ 12 O'Clock

Infiltration: **None** Pipe Seal Cond: **Sound**

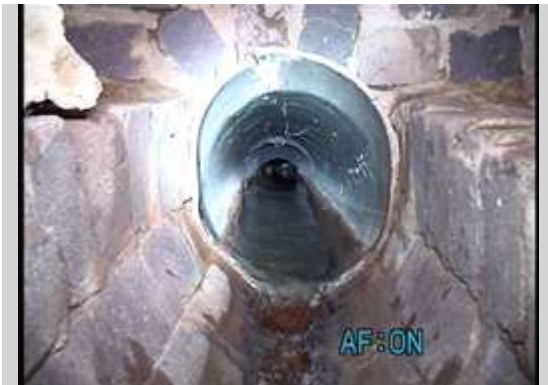
6 O'Clock Inflow

8 in. Circular Gravity Sewer
Pipe In @ 6 O'Clock

Infiltration: **None** Pipe Seal Cond: **Sound**
